Gunshot damage to monoplace hyperbaric chamber acrylicLindell K. Weaver^{1,2,3}; Kayla Deru^{1,2}; John Foley⁴¹ Division of Hyperbaric Medicine Intermountain Medical Center, Murray, Utah U.S., and² Intermountain LDS Hospital, Salt Lake City, Utah³ Department of Medicine, University of Utah School of Medicine, Salt Lake City, Utah⁴ Rocky Mountain Multiple Sclerosis Clinic, Salt Lake City, UtahCORRESPONDING AUTHOR: Lindell K. Weaver – lindell.weaver@imail.org**ABSTRACT**

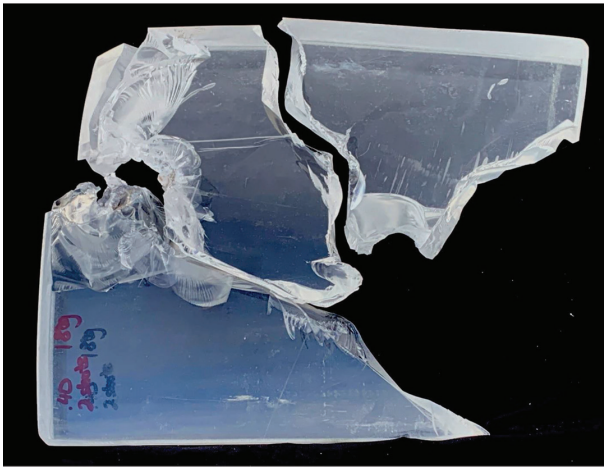
Acrylic section test results are presented in Table 1. Testing on the smallest caliber weapon (0.22 LR handgun) was abandoned for futility after failing to notably damage the acrylic. The remaining handguns required from two to 12 shots to fully break the acrylic sections. All shots from the tested rifles fully penetrated the acrylic. Figure 3 shows typical breakage.

▲ FIGURE 3. Representative acrylic section showing damage from multiple impacts. This section underwent two rounds of testing with a .40 caliber handgun and 180 grain ammunition and required only two shots to break.

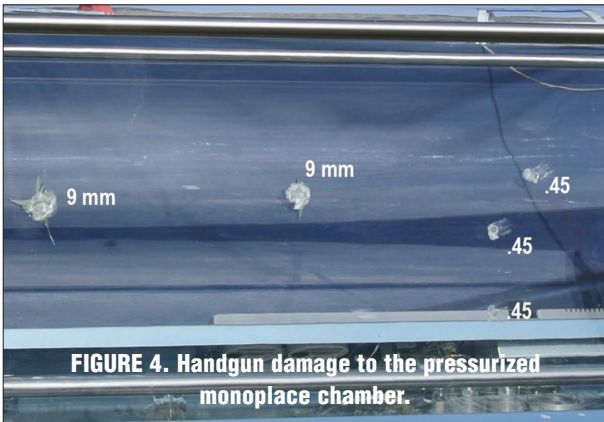
The chamber was hit twice with 9 mm and three times with .45 caliber handguns. Each caused visible impact, and the 9 mm shots caused small linear fractures radiating from the impact site (Figure 4). The chamber remained pressurized. The AR-15 was then fired and impacted approximately 30 mm right of center of one of the 9 mm impact sites. That shot caused a much larger defect but did not penetrate the acrylic. A second shot from the AR-15 60 mm left of the same 9 mm impact breached the chamber and caused rapid depressurization over a seven-second interval (Figure 5). Three additional AR-15 shots in separate, undamaged areas fully penetrated the unpressurized chamber (Figure 6). Two shots from the PS90 at 60 feet failed to breach the depressurized chamber. Two 12-gauge shotgun impacts (2-3/4-inch high brass, #4) from the handgun position (12 feet) near one another significantly damaged the exterior of the acrylic but also failed to breach the unpressurized chamber.

FIGURE 4. Handgun damage to the pressurized monoplace chamber.
