## ADCI

### SAFETY ALERT!

#### DDC Chamber View-port catastrophic failure

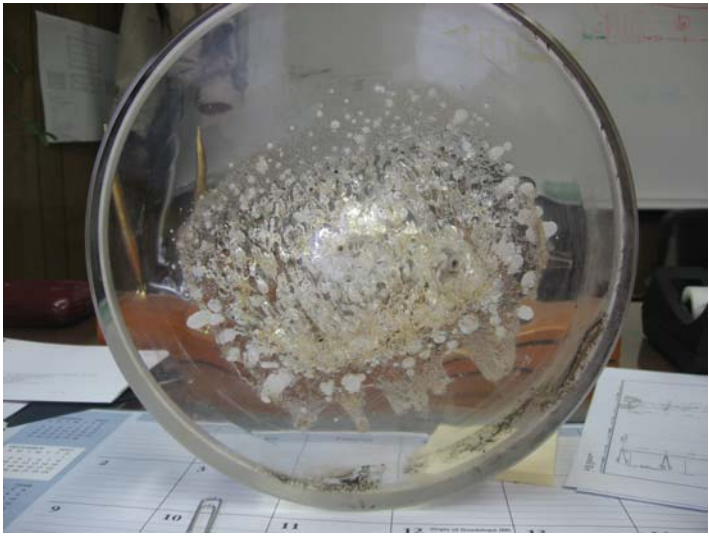
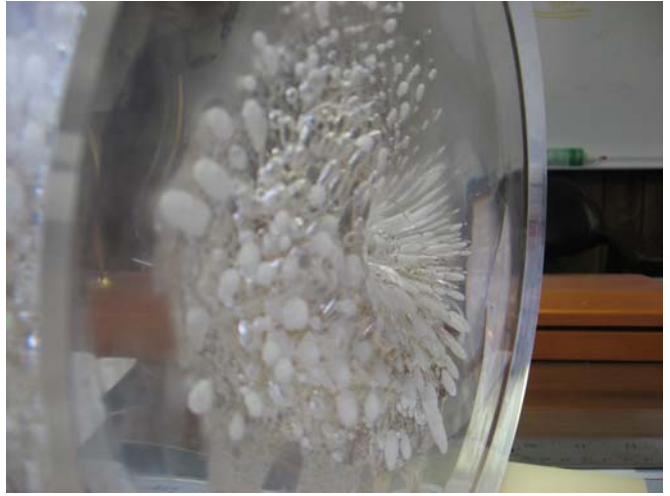
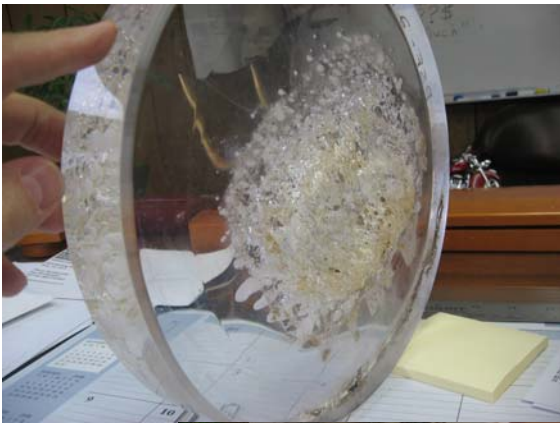
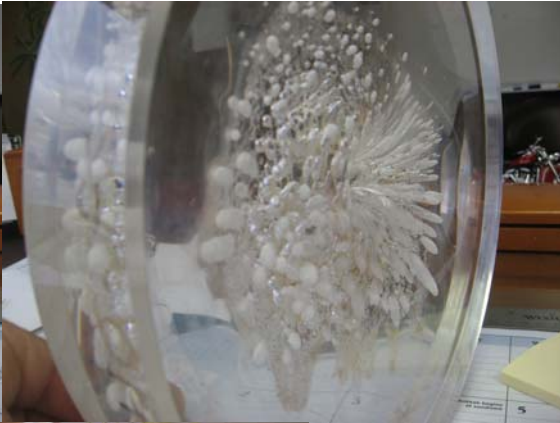
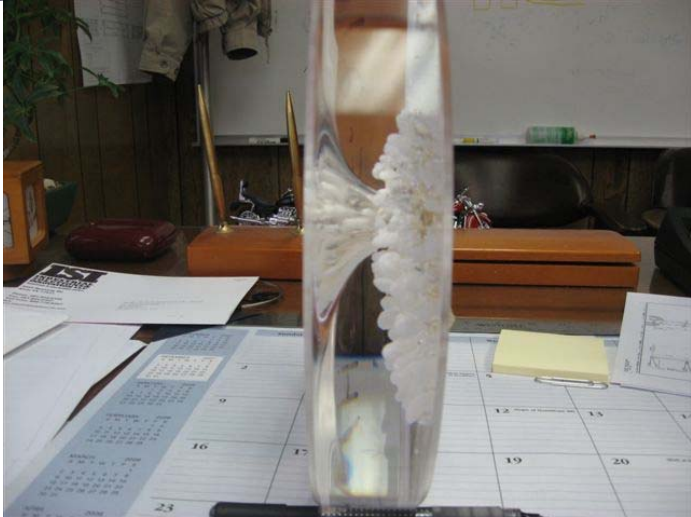
This view-port was in a deck chamber where someone had placed droplight too close to the port. The resulting radiant heat from the lamp exceeded the design temperature of the view-port (125 deg. F / 51.6 deg. C.) Enough heat was generated to allow the view-port to become soft and pliable enough to allow the pressure in the chamber to flow towards atmospheric pressure. (See pictures attached) The pressure boundary was breached and the chamber vented through the view-port to atmospheric pressure. No further information on this incident is available. The danger of incandescent light bulbs in close proximity to chamber ports is well known in the diving industry. To mitigate this danger, many diving contractors have changed to the fluorescent bulb drop lights, with the understanding that they operate at a lower temperature. **WE HAVE NOW DETERMINED THAT FLORESCENT LAMPS CAN ALSO GENERATE HEAT IN EXCESS OF 140 DEGREES!**

Measured temperatures from florescent drop lights have averaged 145 deg. F / 62.7 deg. C. (20 deg. F / 6.6 deg. C. over maximum design temperature)

LED drop lights are exhibiting temperatures under 100 deg. F / 37.7 deg. C.

Do not put drop lights in contact with chamber view-ports, even florescent drop lights can generate enough heat to cause the view-ports to overheat. You must always assess the heat generated from any bulb and make sure you position the bulb a sufficient distance away from the port to eliminate the possibility of any heat build-up on the face of the port. If the port feels warm to the touch, the bulb is too close!!

LED lamps are under close investigation and will most likely replace the commonly used florescent droplight.
