Medtronic

SYNCHROMED[®]

ISOMED[®]

Implantable infusion systems

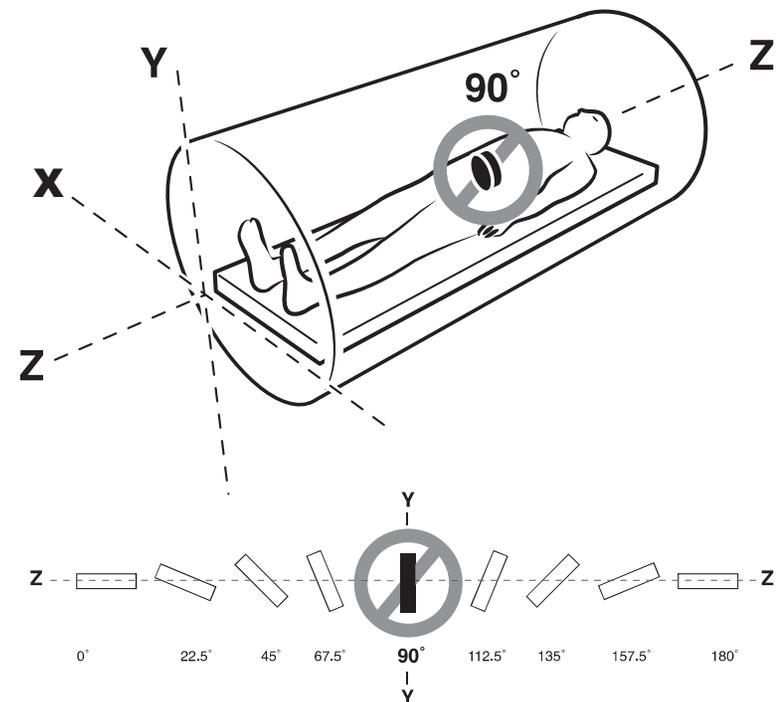
Figure 1. Pump positions in relation to z-axis MRI orientations

90° alignment of an implanted pump with the z axis (Figure 1) of 1.5-T and 3.0-T horizontal, closed-bore magnetic resonance imaging (MRI) scanners can cause MRI-induced demagnetization of the internal pump motor magnets, which can result in permanent, nonrecoverable stoppage of the pump. This is due to the orientation of the pump with respect to the magnetic field of a horizontal, closed-bore MRI system. SynchroMed II pump performance has not been established using other types of MRI scanners such as open-sided or standing MRI.

Note: If the pump face is oriented at 90° to the z axis, the refill port would be facing towards the patient's feet or head.

Prior to MRI, the physician should ensure the pump is not oriented 90° with respect to the z axis of the MRI scanner (see Figure 1). The physician should also determine if the patient implanted with a SynchroMed II pump can safely be deprived of drug delivery. If the patient cannot be safely deprived of drug delivery, alternative delivery methods for the drug can be used during the time required for the MRI scan. If there is concern that depriving the patient of drug delivery may be unsafe for the patient during the MRI procedure, medical supervision should be provided while the MRI is conducted.

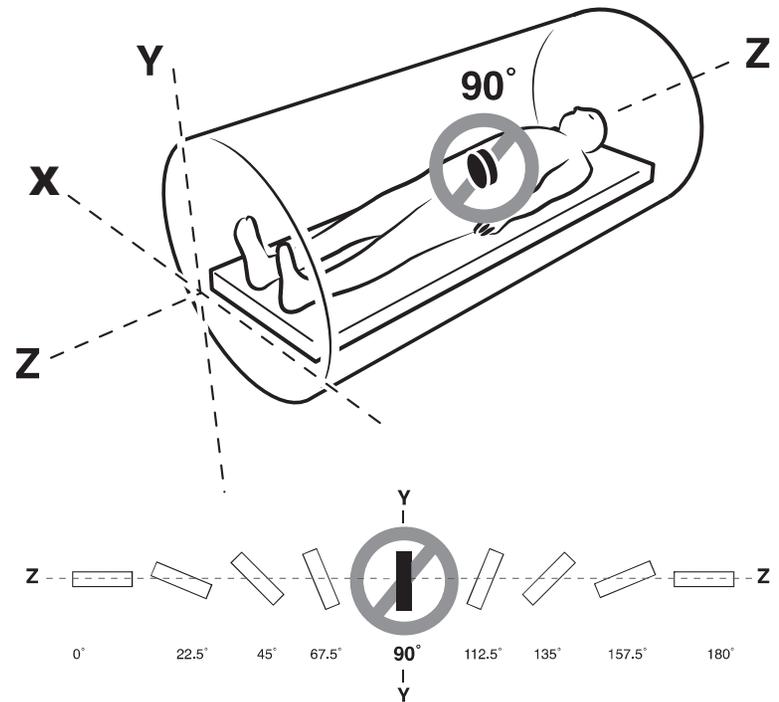
Figure 2. Pump positions in relation to z-axis MRI orientations

90° alignment of an implanted pump with the z axis (Figure 2) of 1.5-T and 3.0-T horizontal, closed-bore magnetic resonance imaging (MRI) scanners can cause MRI-induced demagnetization of the internal pump motor magnets, which can result in permanent, nonrecoverable stoppage of the pump. This is due to the orientation of the pump with respect to the magnetic field of a horizontal, closed-bore MRI system. SynchroMed EL pump performance has not been established using other types of MRI scanners such as open-sided or standing MRI.

Note: If the pump face is oriented at 90° to the z axis, the refill port would be facing towards the patient's feet or head.

Prior to MRI, the physician should ensure the pump is not oriented 90° with respect to the z axis of the MRI scanner (see Figure 2). The physician should also determine if the patient implanted with a SynchroMed EL pump can safely be deprived of drug delivery. If the patient cannot be safely deprived of drug delivery, alternative delivery methods for the drug can be used during the time required for the MRI scan. If there is concern that depriving the patient of drug delivery may be unsafe for the patient during the MRI procedure, medical supervision should be provided while the MRI is conducted.
